Bushfire Mitigation Plan 2022-23
Glenrowan West Solar Farm
Revision 6

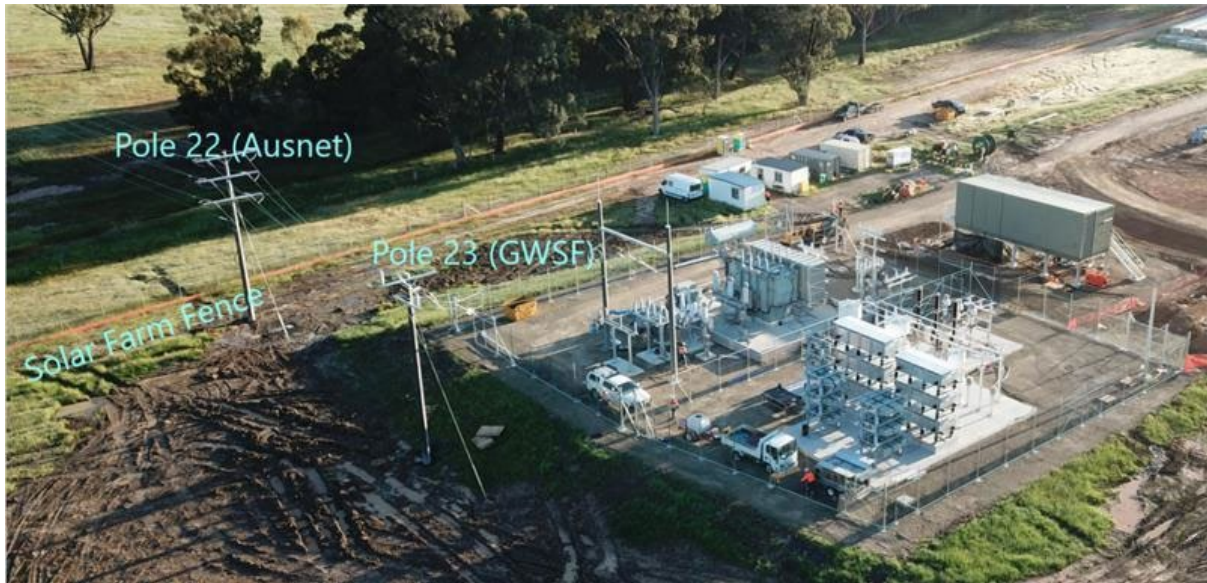
Figure 1 – Electrical Infrastructure

In respect of this Bushfire Mitigation Plan, this plan applies to the overhead lines, poles, hardware and apparatus up from the line posts within the substation up to but not including pole 22. These items remain within the solar farm fence boundary. Pole 22 and related items are under the control and ownership of Ausnet.

Glenrowan West Solar Farm owns and is responsible for the span from Pole 22 to Pole 23 and the span to the Glenrowan West Solar Farm substation. Pole 23 is a concrete pole. The at risk electric line and surrounding area will be maintained by Glenrowan West Solar Farm.

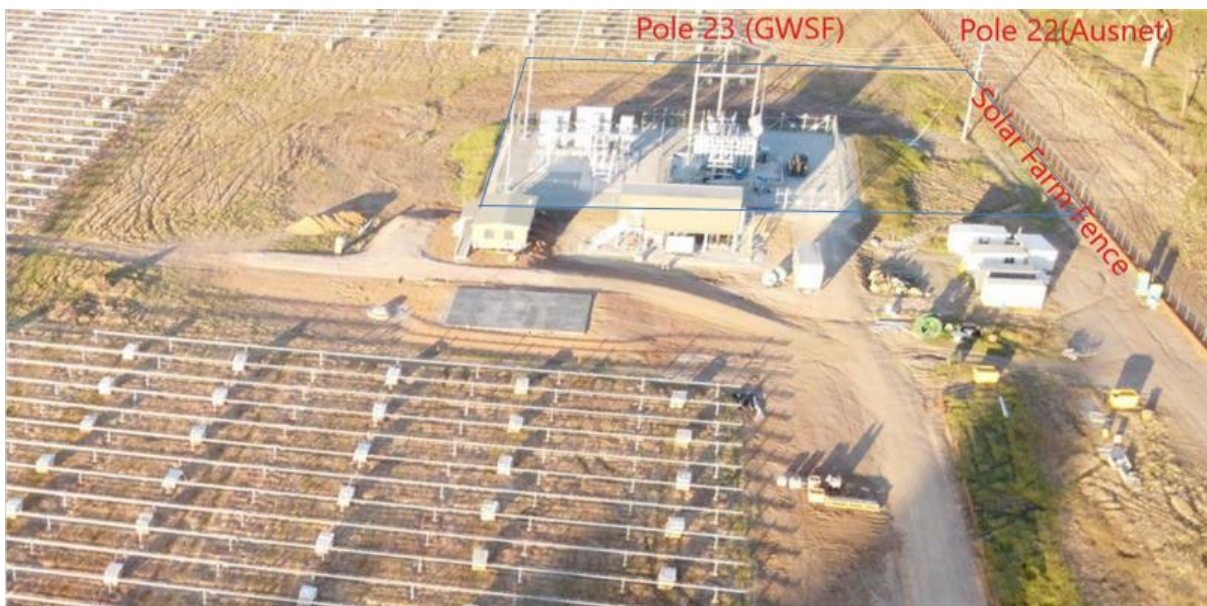
Figure 2 – Electrical Infrastructure

For the purposes of this plan, the easement is defined as the cleared area within the blue markings in Figure 2: Electrical infrastructure.
